**General Service Bulletin No. 1**

Subject: Trailing Edge wing drainage

Models: All Speedsters, Sportsters, Cloudsters, and Skyrangers

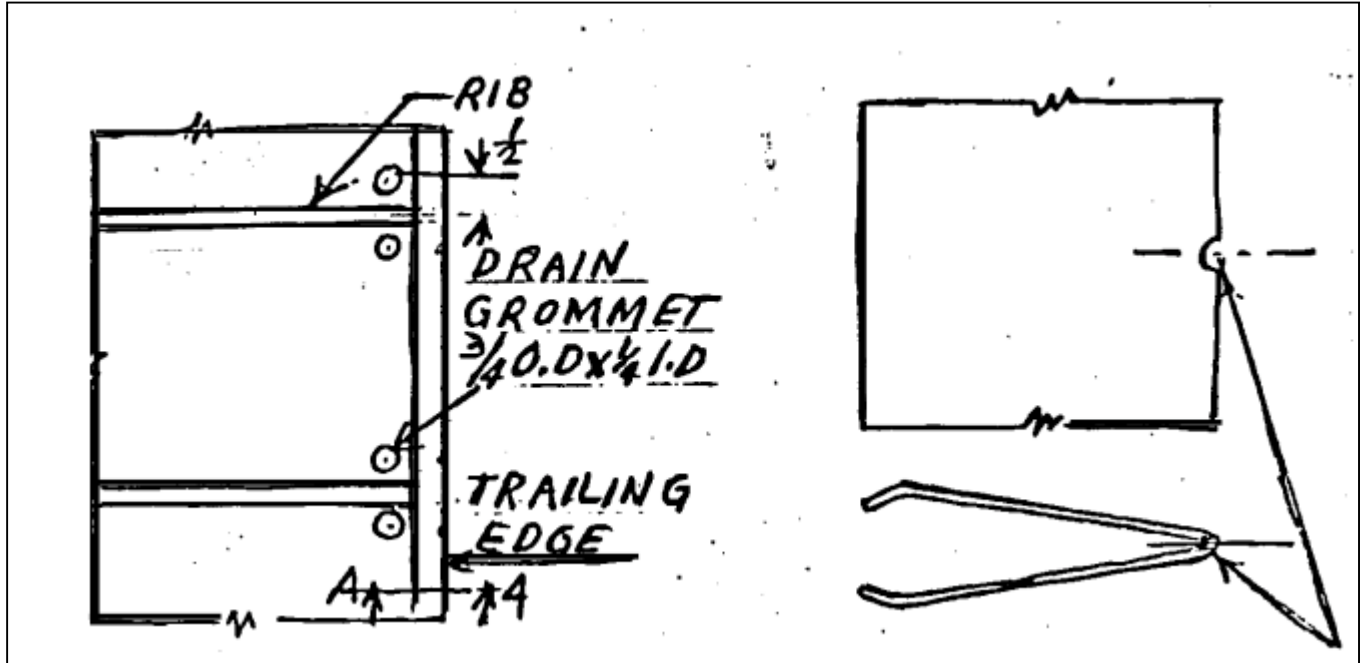
Detail of drain hole locations (view looking up at bottom side of wing)

Section A-A drill  $\frac{1}{8}$ " hole on each side of rib in trailing edge.

2. Additional drain holes and grommets should be located in the trailing edge portion of the wing, including the trailing edge portion of the wing in the aileron cut-out region and the aileron itself. In addition to this, 1/8" holes should be drilled through the aluminum trailing edge horizontally in the bend of the trailing edge. Remove any fabric that may be pushed into the hole by the drill. See Sketch below.

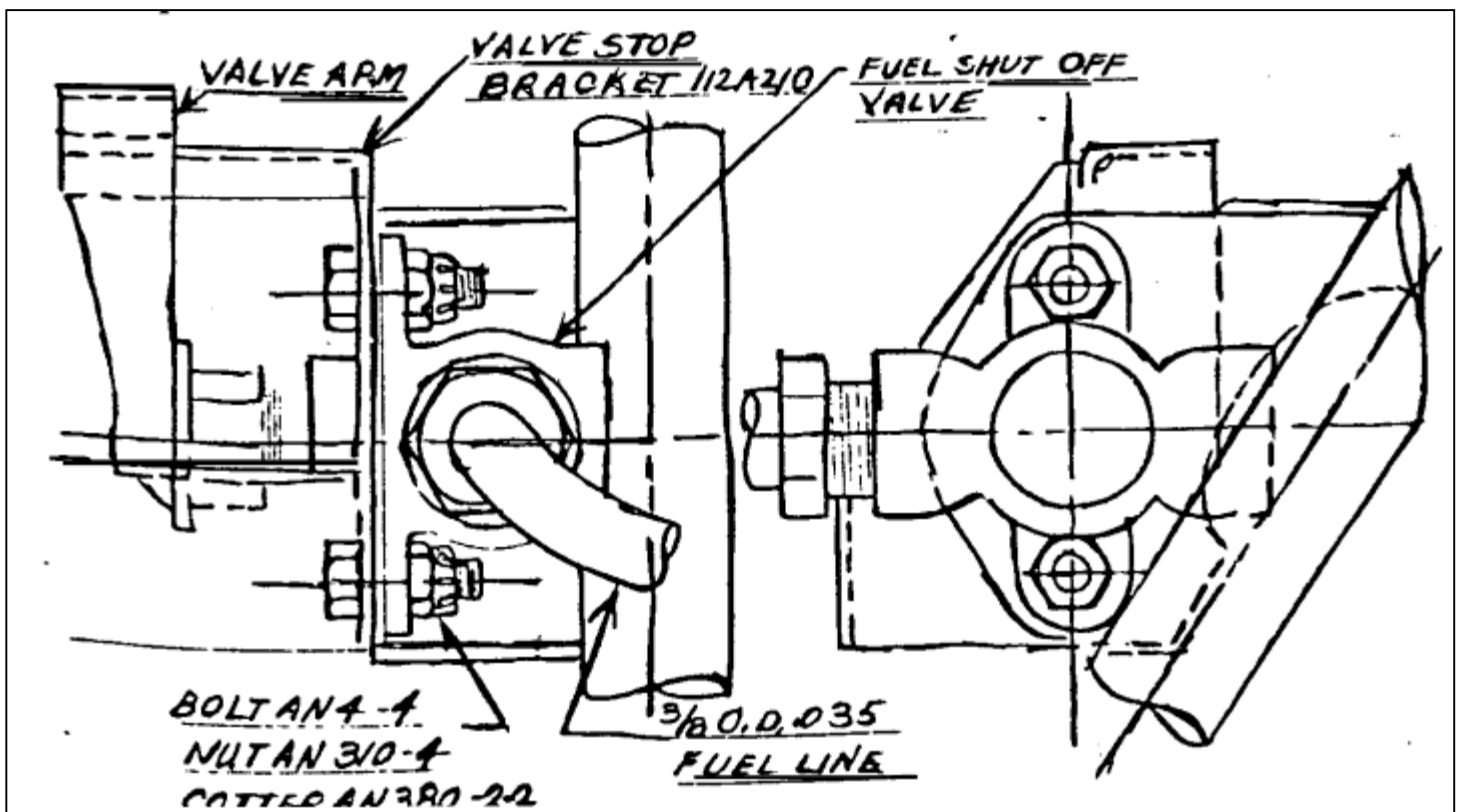
The following sketch is self-explanatory in regard to mounting bracket 112A210. It is necessary, however, to disconnect the fuel valve actuating handle, valve arm and valve retaining bolts to mount bracket. These parts are readily accessible by removing the right hand side panel kick pad. Be certain to properly safety all parts before replacing the kick pad.

It is not necessary to disconnect any fuel lines to install the bracket (Part 112A210) and this should not be done. Caution should be exercised in installing the bracket, however, so as not to cause fuel system leaks.

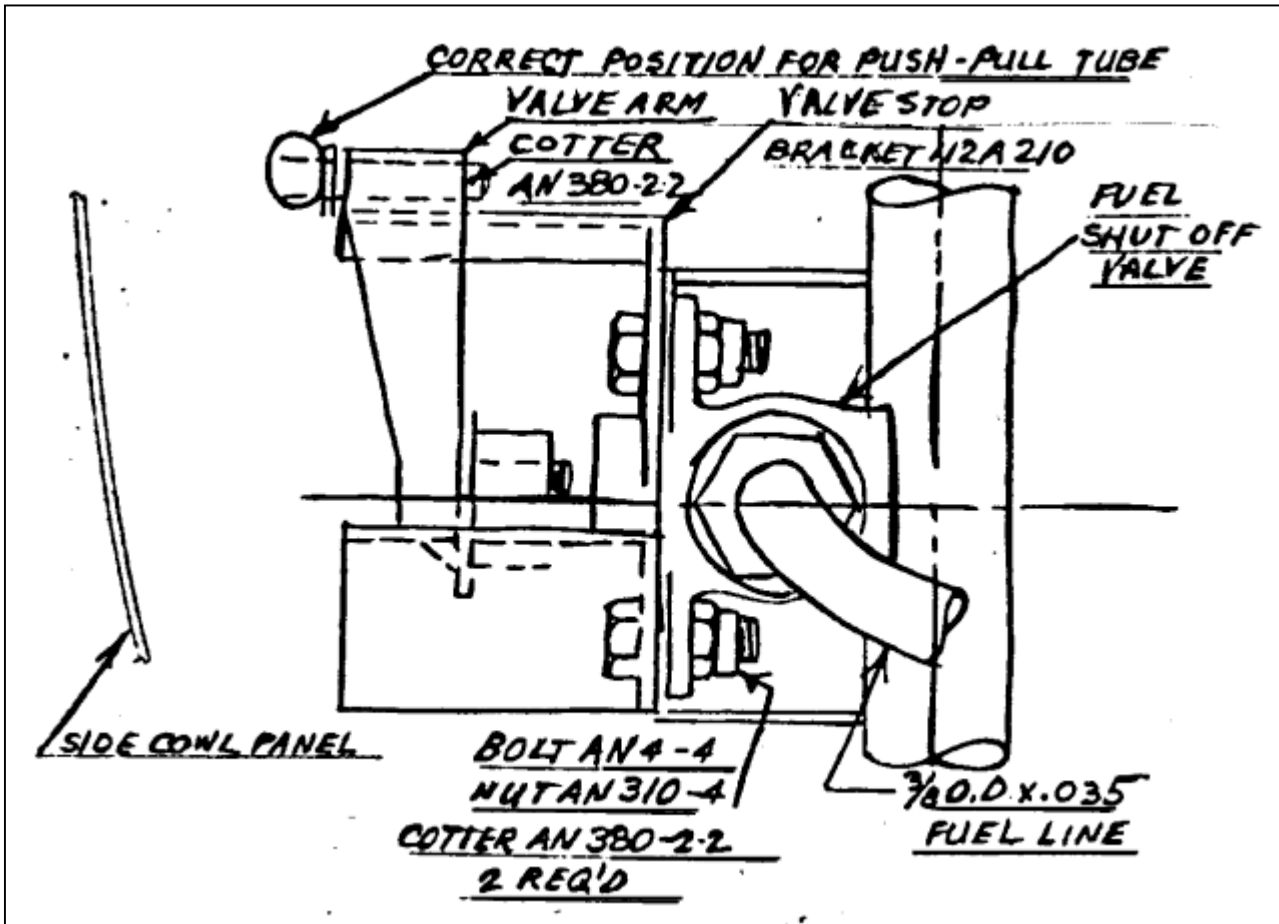
2. In one case the fuel valve actuating lever was incorrectly installed, which did not permit the valve to be opened the full amount due to interference between the valve actuating handle and the new type stop bracket. This interference was due to the valve actuating (push-pull) handle being incorrectly installed. In order to function properly without interference, it is necessary for the push-pull tube to be inserted toward the fuel valve from the region between the valve and cowling. The sketch below will indicate the desired position for the push-pull tube.

3. It is suggested that your installation be checked to make certain that the push-pull tube is correctly installed in your airplane.

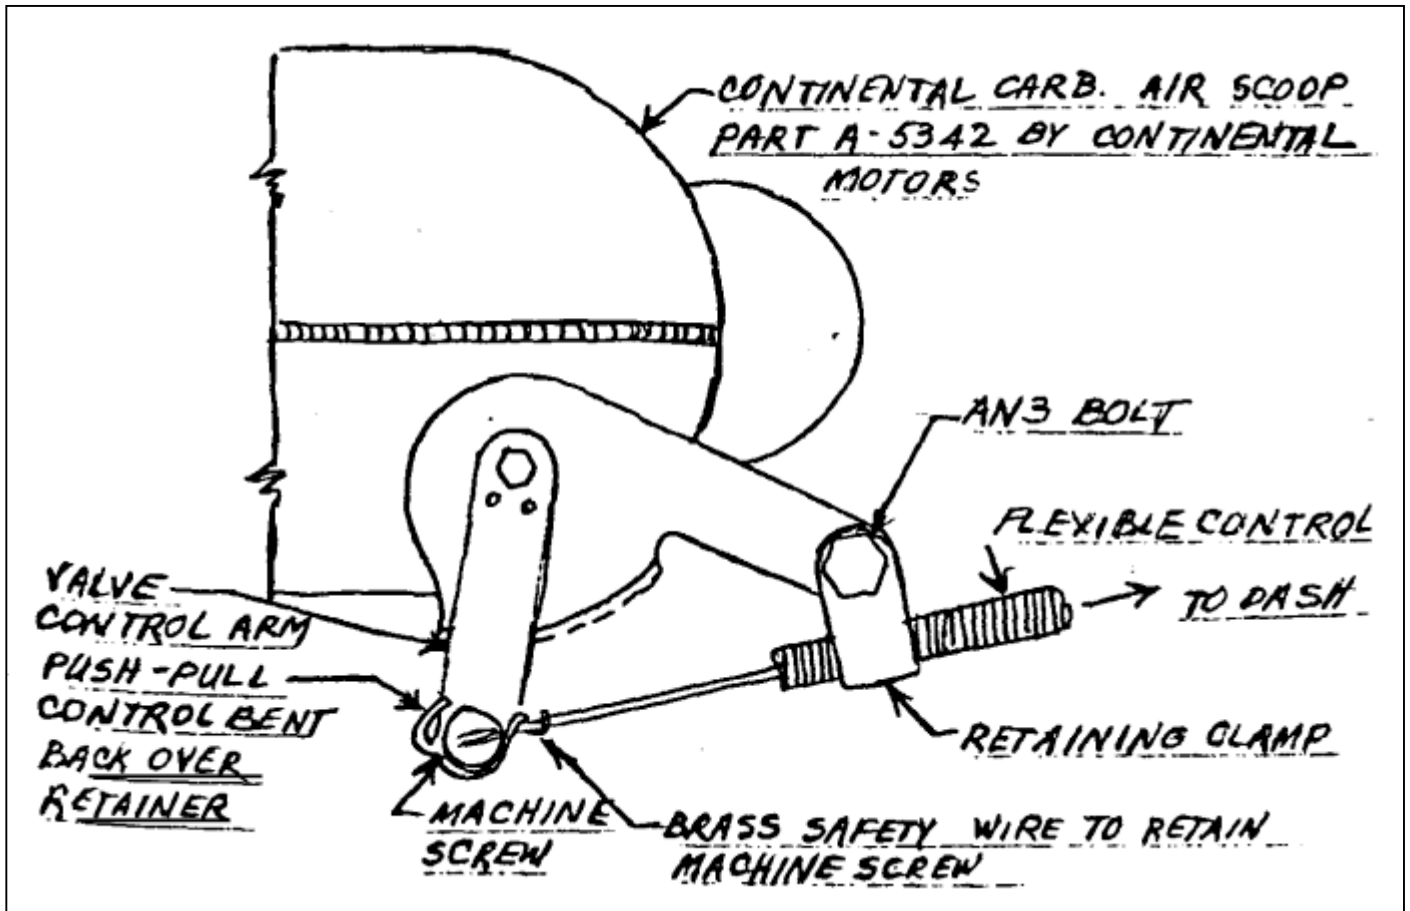
1. This bulletin is being promulgated to assist you in maintaining the airworthiness of your airplane. It is suggested that the attachment of the flexible control to the carburetor heat valve actuating arm be checked for conformity to the sketch below.

2. In the event that the attachment of the flexible casing is not in conformity to the sketch below, it should be altered to conform before again using your airplane as the possibility of it becoming loose in flight so that the heat valve could not be operated may exist.

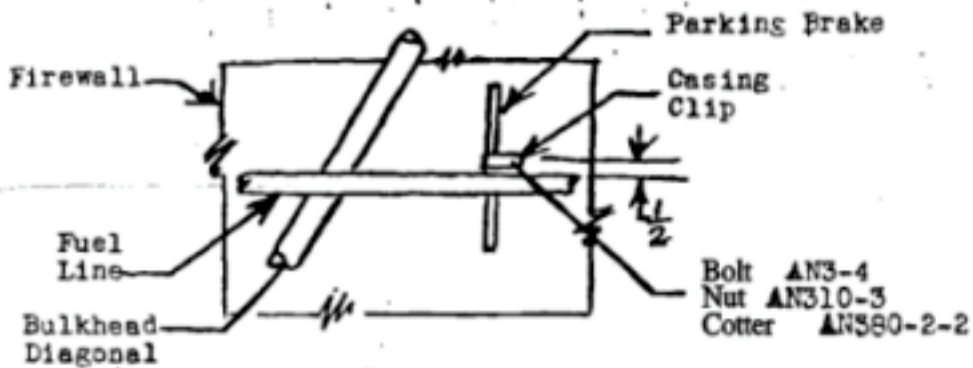
Fig. 1

2. On the aft side of the firewall the parking brake bowden casing passes at right angles to the 3/8 O.D. fuel line and passes between the firewall and the fuel line. There is a space between the firewall and the fuel line of approx. 7/8" at this point. In order to prevent the semi-loose bowden casing from vibrating against the fuel line and eventually wearing it through, it is recommended that a clip (Note figure 1) be placed around the bowden casing, retaining it firmly to the firewall at a point approx. 1/2" above the fuel line. This clip should be bolted through the firewall and safetied in place. This will prevent the bowden casing from wearing the fuel line at this point. Clips may be readily made by using .135 or .049 steel or even .051 aluminum sheet bent to the proper shape and then bolted in place. However, if desired, clips of the proper type are available upon request from Rearwin Aircraft & Engines, Inc.

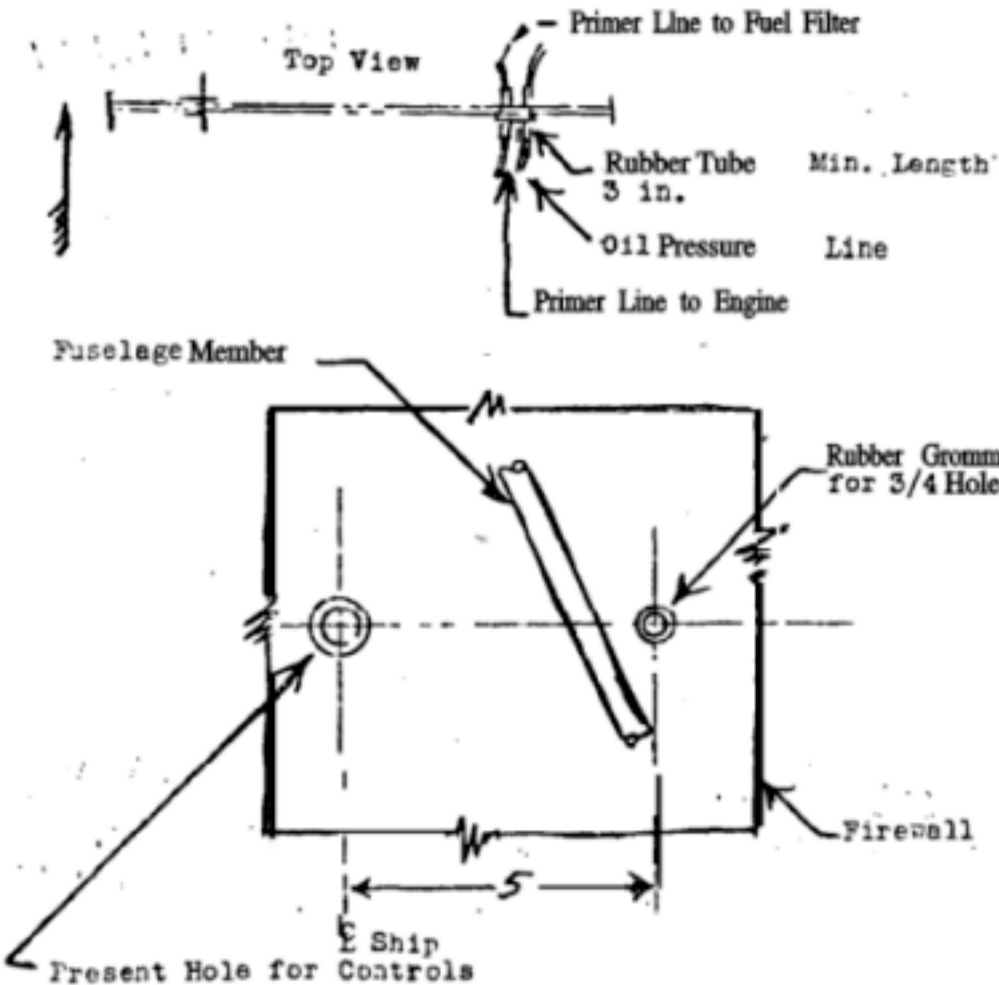
3. On the subject airplanes the primer line from the fuel filter to the primer and the line from the primer to the engine, as well as the oil pressure line, pass through a firewall opening through which ignition wires; temperature casing, and flexible engine controls pass. In view Of the possibility of these units wearing through the primer and oil pressure lines, it is recommended that an additional hole be placed in the firewall approx. 5" to the right of the present hole, which is centrally located, and at the same height vertically. The hole should be 3/4" in diameter. A standard rubber or neoprene grommet is to be placed in this hole to protect the primer and oil pressure lines, which are to pass through this hole from wearing on the firewall The oil pressure line and the large primer line are to be encased in a rubber tube for a distance about three inches of its length at the point where it passes through the firewall. This tubing is to be cemented in place. (Refer Fig. 2 for further clarification.)

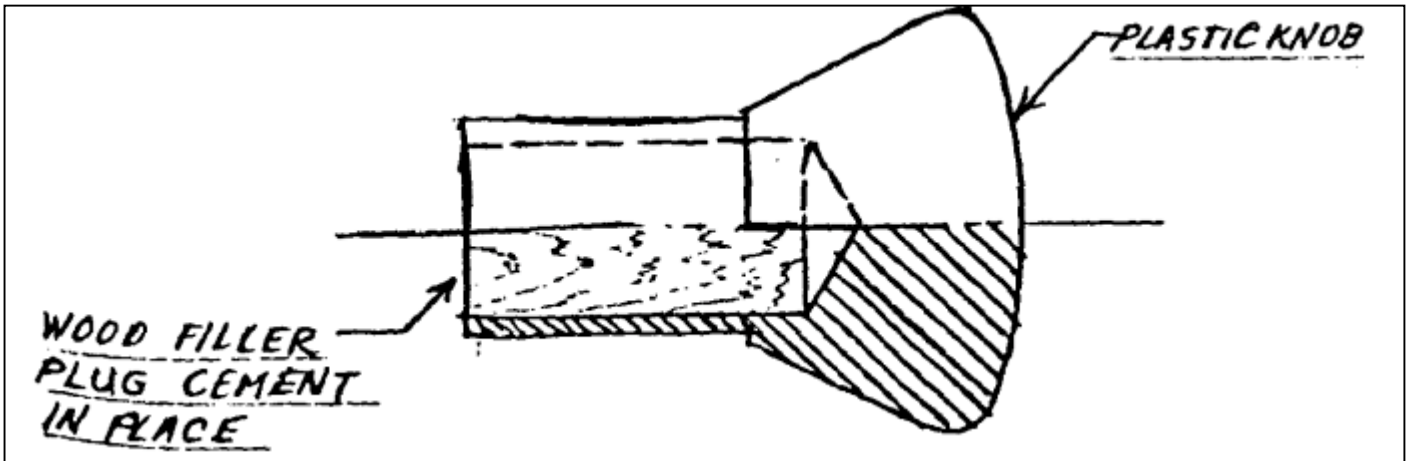
The control column plastic knobs at the present time have a hole drilled on the inside about 1-1/4" deep. This results in weakening the section of the knob at the top of the control column, which in a few cases has resulted, after considerable usage, in the snapping off of the control knob at the critical section. In view of the fact that fractures of this type occur instantly and are not gradual, it is considered that a certain hazard may exist during some maneuvers, such as take-off and landing, if this difficulty is experienced during these maneuvers.

In order to remove the possibility of this occurring, it is recommended that a wood plug be fitted and cemented in place in the hole in the control stick knob. This will add greatly to the strength of the knob at the critical section, It is necessary for the plug to extend the full depth of the hole in order to obtain the desired results, Note the sketch below, After the knob is plugged, it should be re-cemented in the control column, using Plastic Cement.

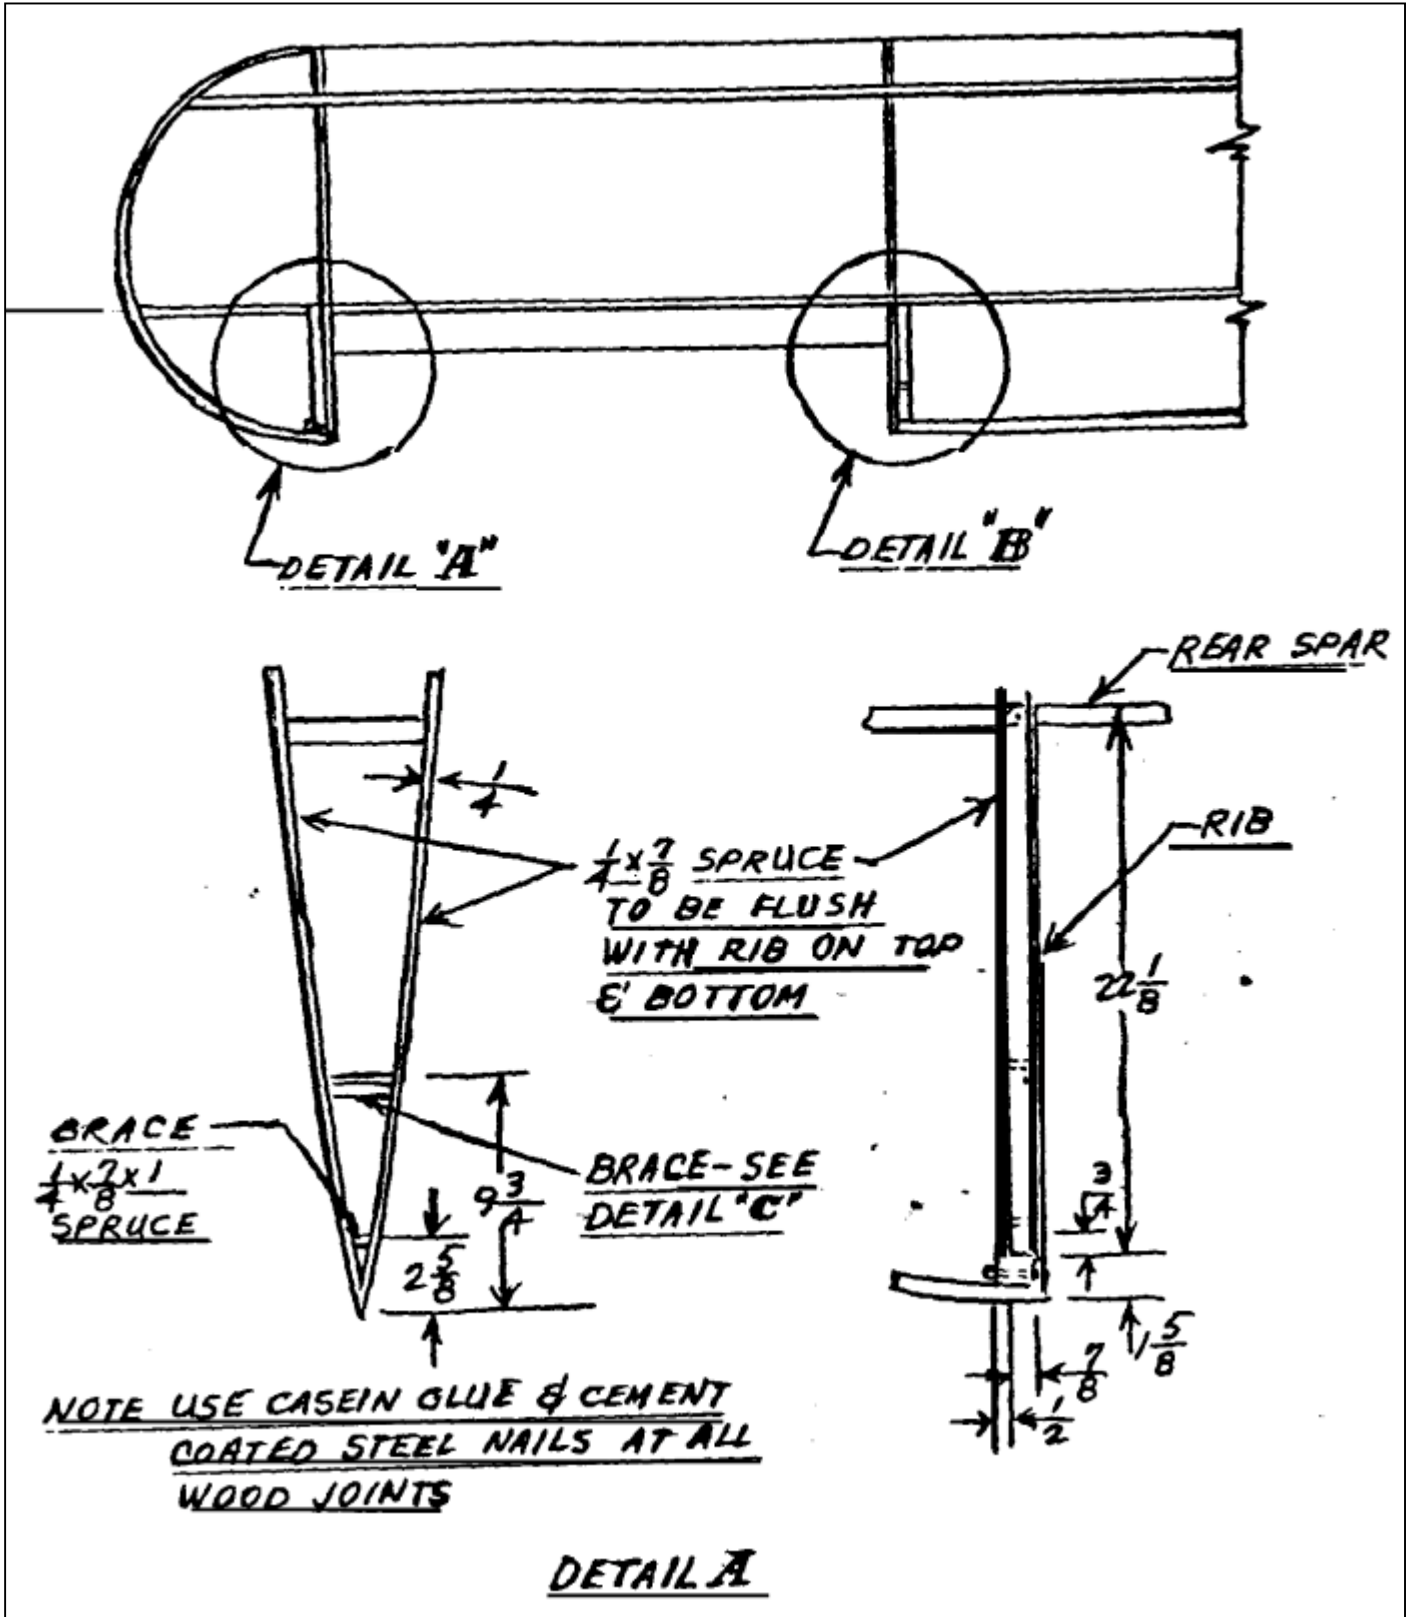
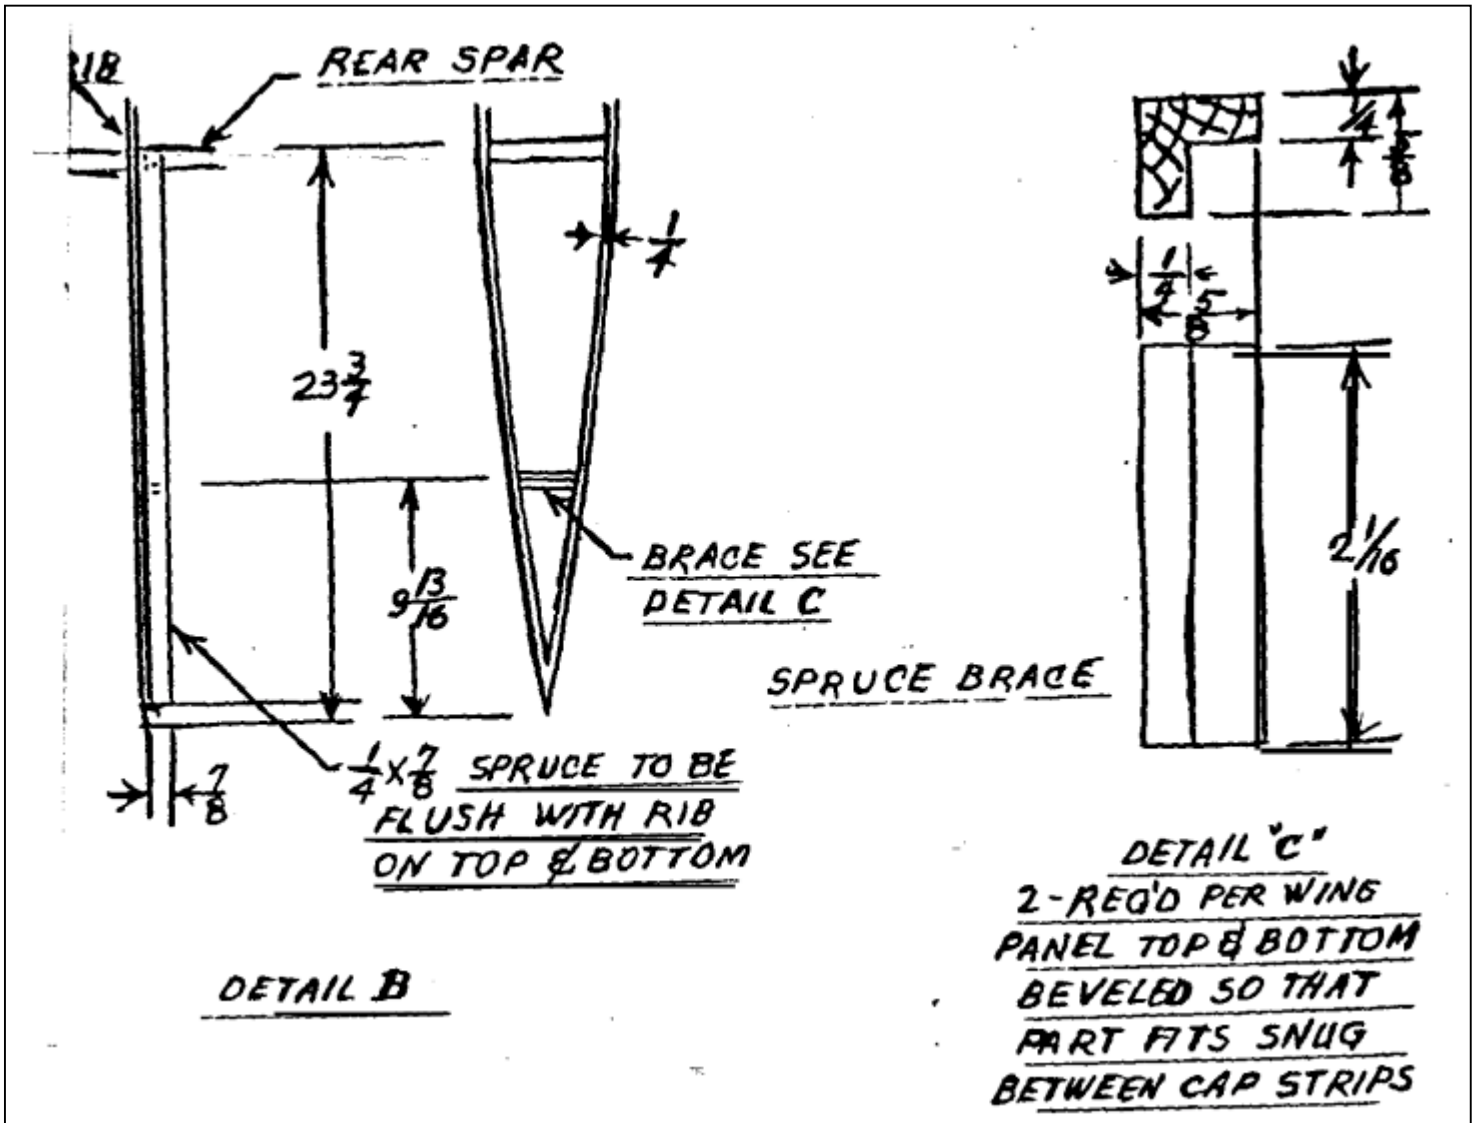
Present production calls for reinforcing strips extending along the inboard side of the top and bottom cap strip on wing rib at the inboard end of the aileron cut out. These strips run from the front face of the rear spar to the wing trailing edge and serve to restrain the rib laterally against fabric pull. On some of the earlier airplanes (see serial numbers applicable) the reinforcement strip stopped at the trailing edge of the wing in the aileron section. This resulted in a few cases of the wing rib rupturing just aft of the aileron cut out trailing edge. It is recommended that these strips be added to your airplane to prevent this from occurring. See attached sketch relative to detail of the pertinent strips and their attachment.

It is also desirable to add fabric pull strips to the rib at the outboard section of the aileron cut out section similar to those at the inboard section described in 2nd paragraph above. In this case, it is necessary to add a solids block at the trailing edge of the wing which hooks around the fabric pull strips to restrain them at the trailing edge against the lateral pull of the fabric. This block is bolted in place. For the details of this change refer to the attached sketch. It is recommended that your airplane be altered to comply with this suggestion at an early date.

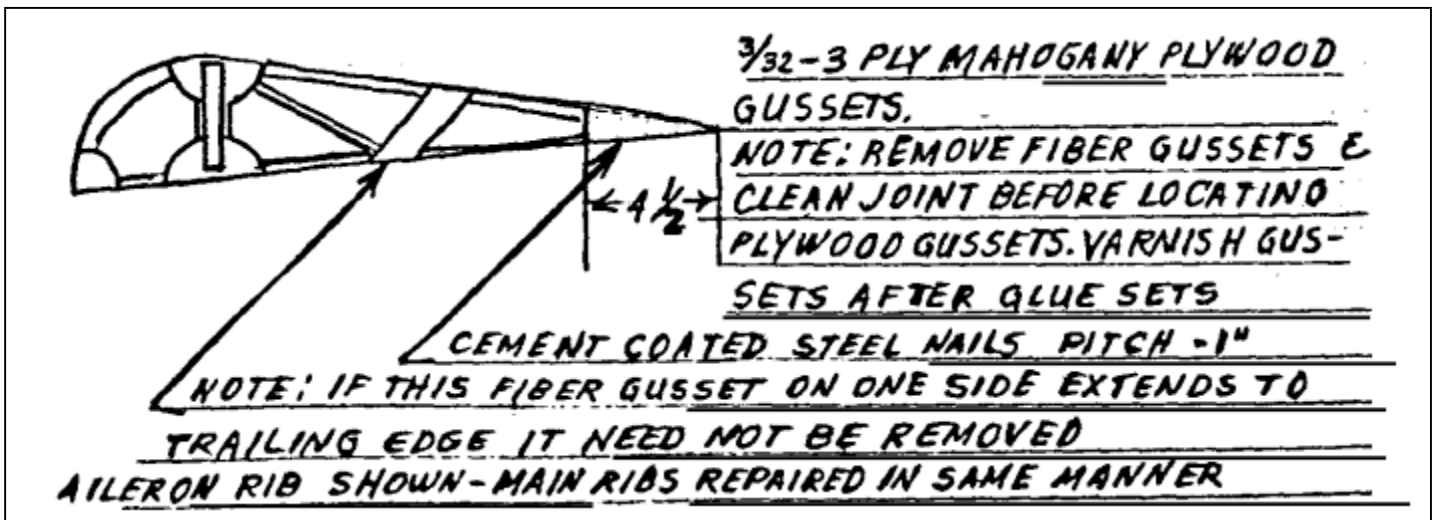
In certain cases the wing trailing edge has been rotated due to fabric pull. In most cases reported, the trailing edge turned upward in the region between the aileron and the fuselage, and it is recommended that the following repairs be executed in your ship to preclude this difficulty, It would probably be well to effect this change on the ailerons, as well as at the trailing edge portion of the wing as a precautionary measure.

It is recommended that 3/32 mahogany 3-ply plywood, resin bonded, gussets be located on either side of the wing rib as outlined in the sketch below, Casein glue should be used and should be mixed and applied in accordance with approved practice. The plywood gussets should be retained by nailing as indicated in the sketch below. In the event that the rib cap strips are injured by the fabric pull, they should be repaired in accordance with approved methods outlined in C.A.R. 18 and A.C.M. 18 issued by the C.A.A.

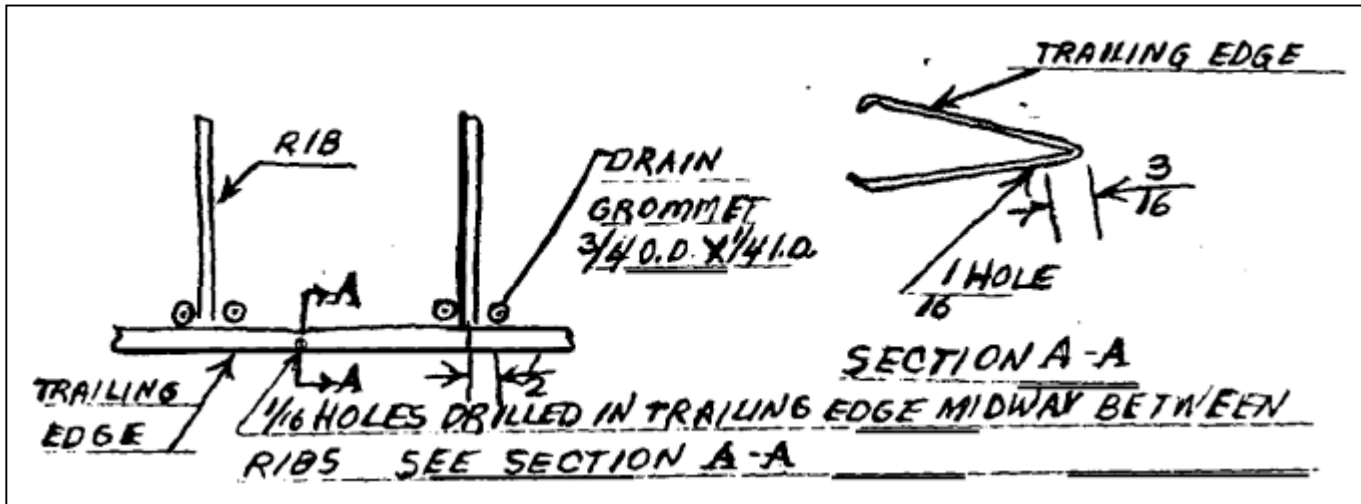
2. Additional drain holes and grommets should be located in the trailing edge portion of the wing and aileron on all of the subject model airplanes. This includes the trailing edge portion of the wing in the aileron cut out region. In addition to this, 1/16" holes should be drilled through the lower surface of the trailing edge approx. 3/16" from the rear edge of the trailing edge strip between all ribs. Note sketch below.

3. The grommets may be attached to the fabric through the use of clear or pigmented dope. No less than two coats should be applied after the coat between the fabric and grommet is applied. The drain holes are, of course, cut after the grommets are in place.

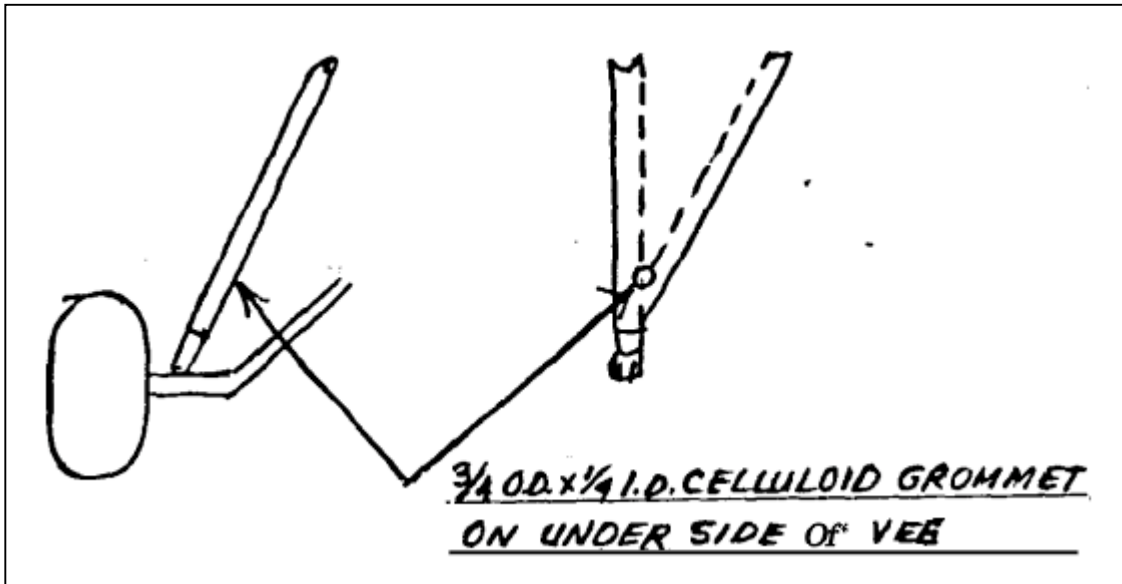
It may be possible for the landing gear vees to retain water between the structural members and the fabric covering at the apex of the vee. In order to remove this possibility, it is recommended that a drain grommet be placed at the apex of the vee on the fabric on the side of the vee nearest the center line of the airplane. This grommet should be applied to both the right hand and left hand vees.

The following sketch illustrates the proper location for the grommets.

Apply grommet by doping in place with either clear or pigmented dope after cleaning the fabric covering. Not less than two coats should be applied after the coat between the fabric and the grommet is applied.

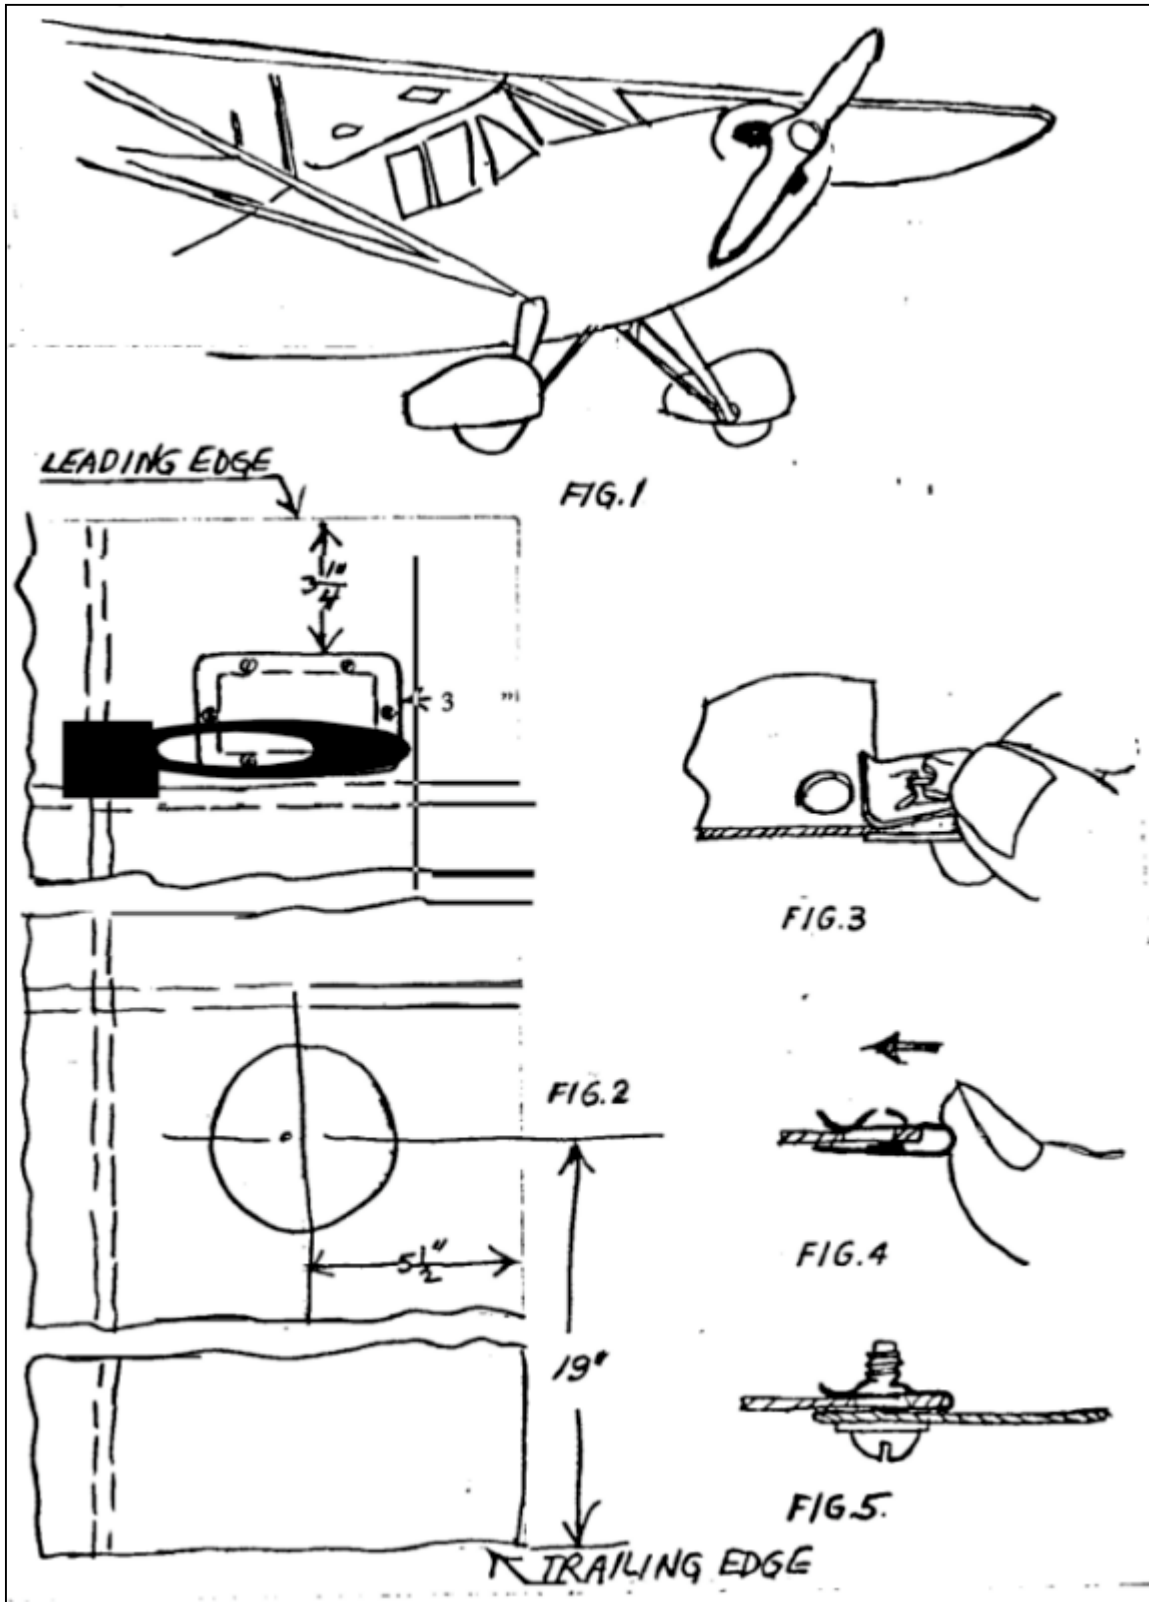
The inspection plate for the front spar should be installed in the leading edge skin immediately in front of the spar as shown in Fig. 1 & 2. In doing this, the following steps should be followed:

The inspection plate for the rear spar should be installed immediately behind the rear spar in the fabric as shown in Fig. 1 & 2. The inspection spate assembly consists of pyraline ring doped to the fabric surface with either clear or pigmented dope. After the ring has dried to the surface, an additional coat of dope should be applied to the exterior of the ring. After drying, the fabric is cut from the ring I.D. and the aluminum plate (retained by a spring clip) is inserted.

- a) Place the cover plate in position approx. as shown in Fig, 2 and use a template in marking location of holes.
- b) Use holes thus marked to lay out opening to be cut in skin, which should be 2" x 4" and centrally located within the area of the holes marked.
- c) Drill 6-1/4" holes in the position previously marked. Care should be taken in drilling holes to avoid tearing of the thin aluminum skin.
- d) Place speed nut clips over edge of skin and push into holes as shown in Figures 3 & 4.
- e) Place cover plate over opening and insert screws. Work should be done with precision in order to get proper alignment of holes with speed nuts.
